NAVAL CIVIL ENGINEERING LABORATORY
Port Hueneme, California

FERRO CEMENT PANELS
VOLUME I

Experimental Evaluation
and Protective Potential

Report No. CR 69.008

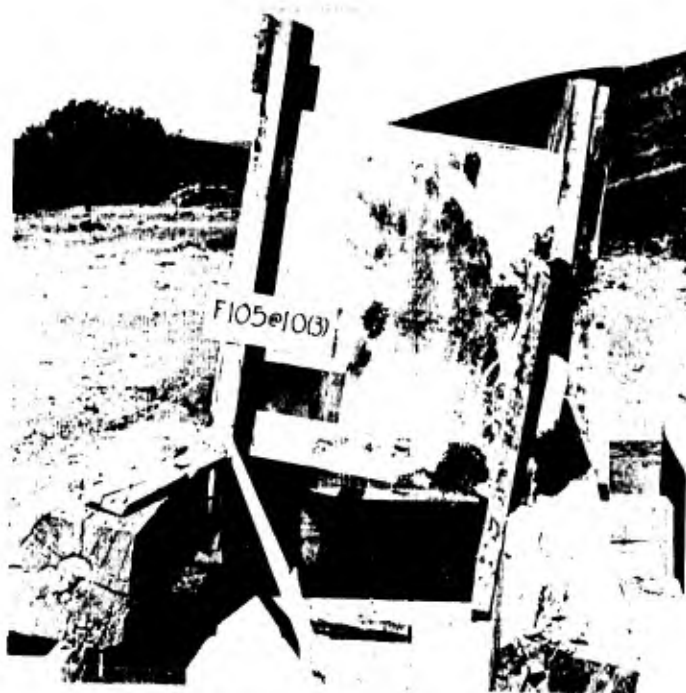
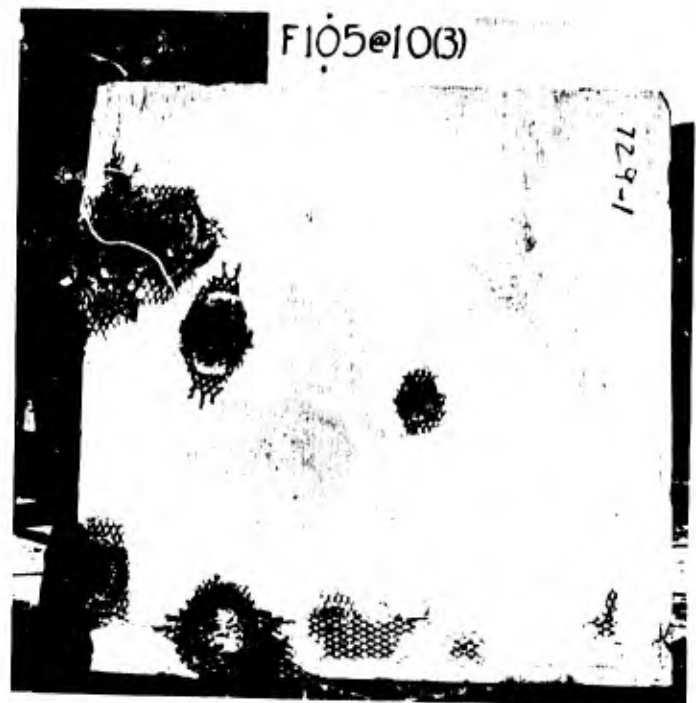
Figure 4-4.310 Rear Face of Intermediate Panel

There was one penetration of the intermediate panel, one embedment creating slight spall on the back face and one hit that cut a large notch in the edge of the panel. The rear panel was undamaged. This indicated that the penetration of the intermediate panel extracted virtually all of the energy of the fragment. The support was pushed backward 11" and considerably damaged. (Fig. 4-4.307)

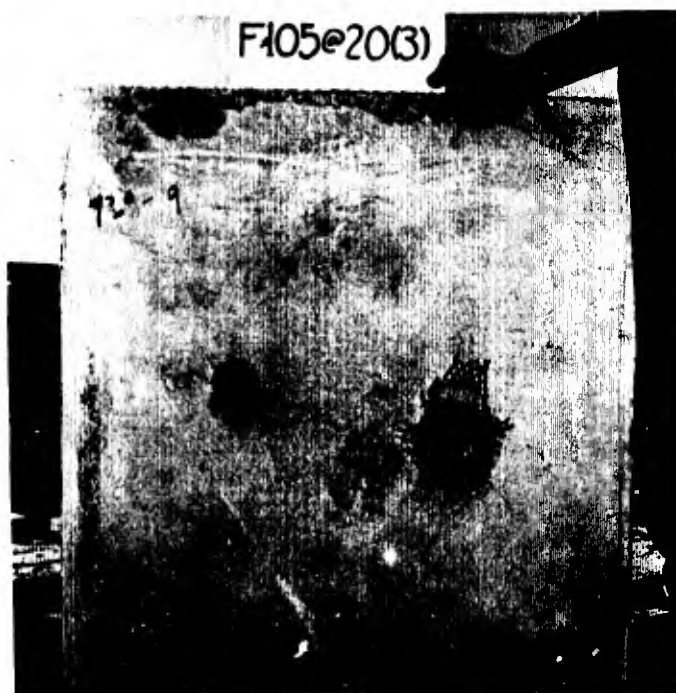
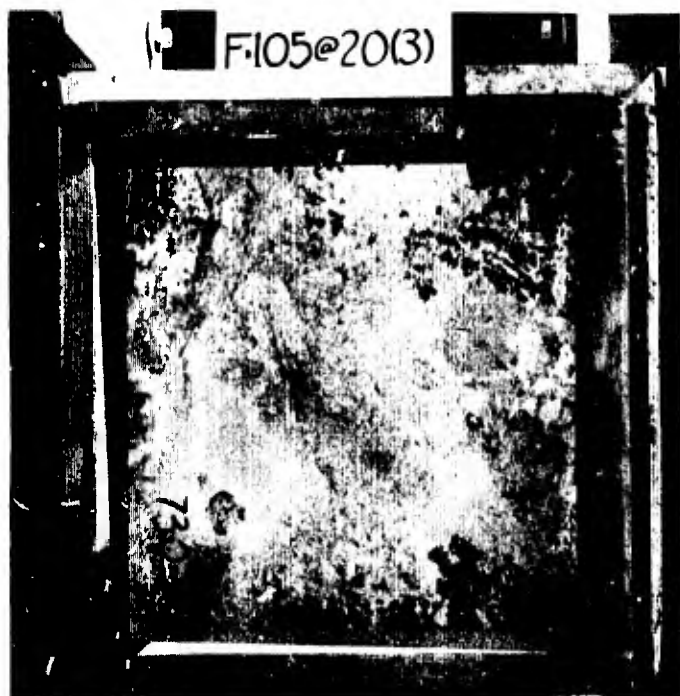
- Figure 4-4.311 Front Panel in Place
- Figure 4-4.312 Rear Face of Front Panel
- Figure 4-4.313 Front Face of Intermediate Panel
- Figure 4-4.314 Rear Face of Intermediate Panel
- Figure 4-4.315 Spall Caused by Impact on Front Face of Rear Panel (Lower Left)
- Figure 4-4.316 Spall and Blister on Back Face of Rear Panel

The penetration of the intermediate panel was made by a large fragment. The support was not displaced.

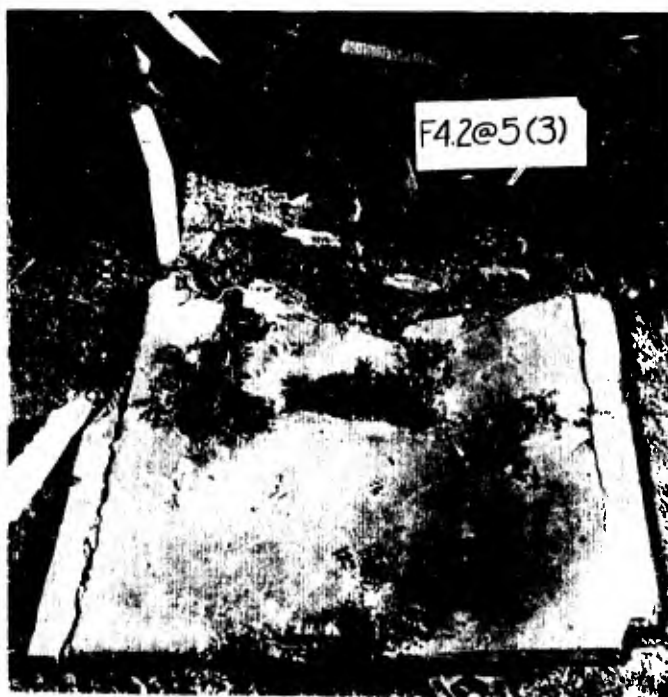
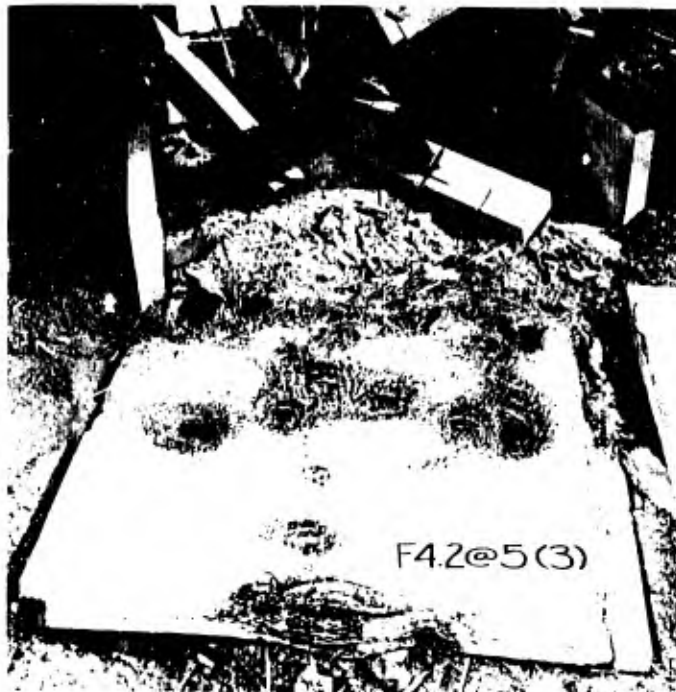
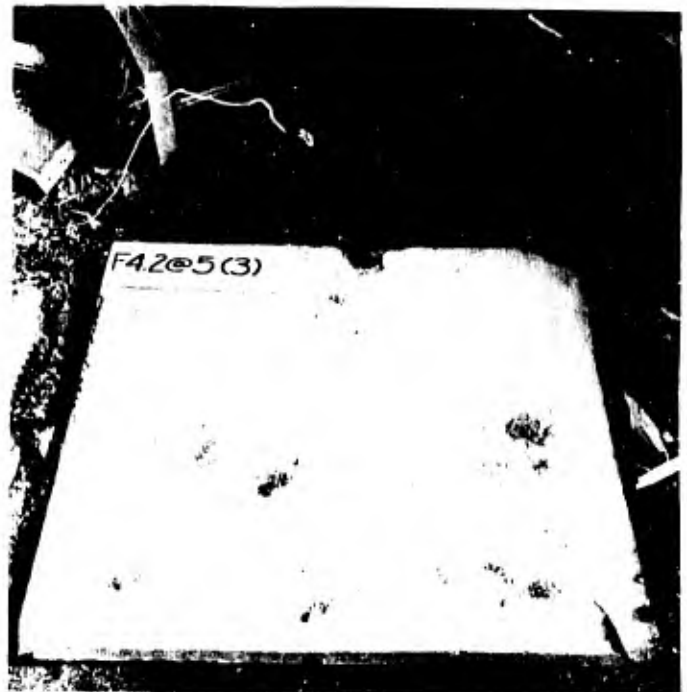
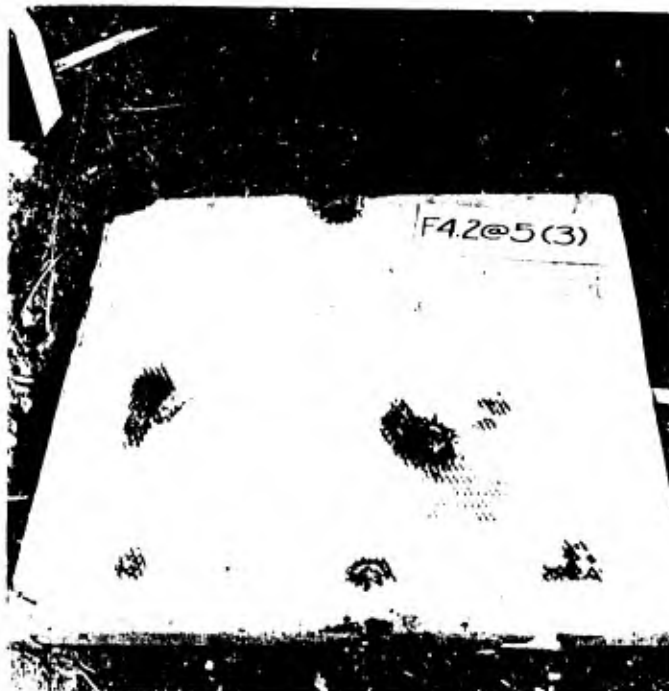
Panel arrangements as described in Paragraph 4-4.2 were exposed to the 4.2 inch mortar shell on August 9. Panels were cast on July 27 and 29, 1968. Results at five foot stand off are depicted in the following figures:

- Figure 4-4.401 Condition After the Shell Burst
- Figure 4-4.402 Front Face of Front Panel
- Figure 4-4.403 Back Face of Front Panel
- Figure 4-4.404 Front Face of Intermediate Panel
- Figure 4-4.405 Back Face of Intermediate Panel
- Figure 4-4.406 Embedment in Rear Panel of only Penetration of Intermediate Panel

Damage to rear panels was limited to the embedment of one large fragment and one deep indentation under exposure to the Shell, Howitzer, 105mm at 5 foot stand off, and one embedment under exposure to the Shell, Mortar, 4.2 inch at 5 foot stand off. Damage to the rear panel is a guide in estimating the damage to protected surfaces screened by a two-panel revetment or overhead cover. The rear panel was only 7 inches away from the intermediate panel. Pronounced spacial attenuation of the kinetic energy of fragments, caused by air drag, was demonstrated by the decrease in intermediate panel damage by fragments encountered by the panels at 6, 10, 12 and 20 foot stand offs.

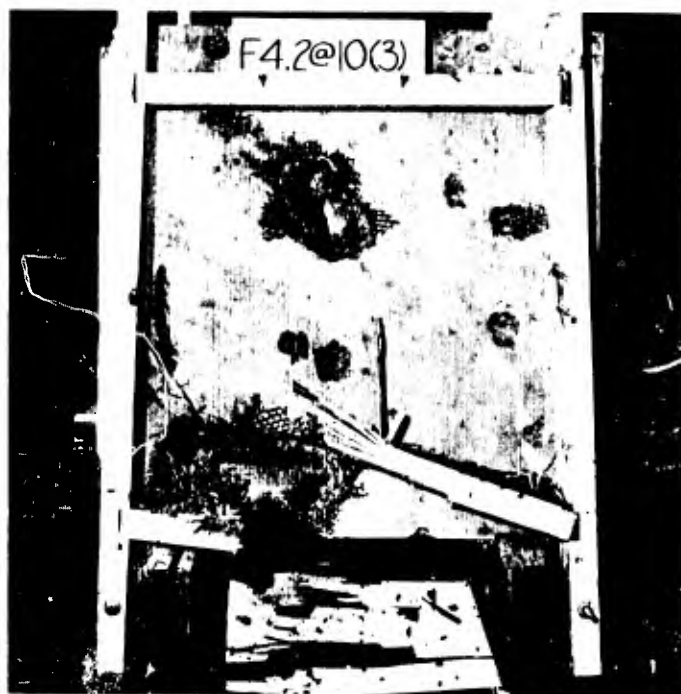
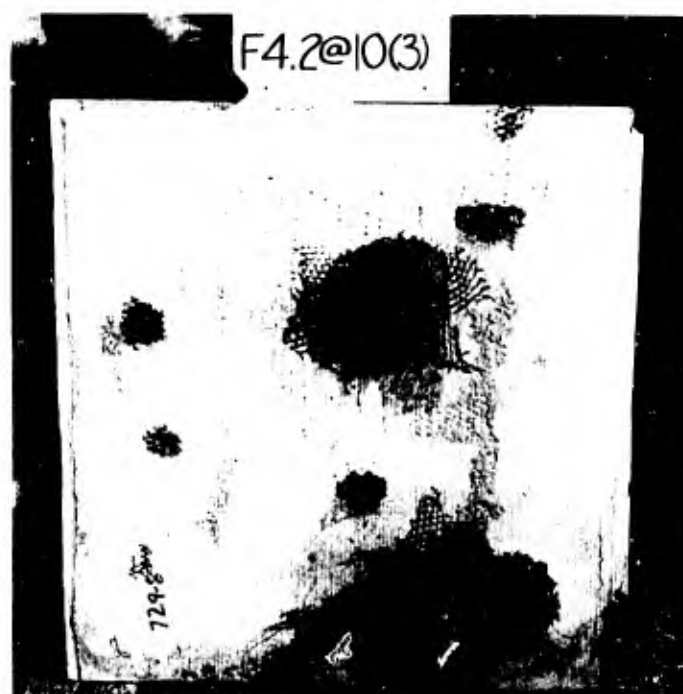
Figure 4-4.410 Back Face of Intermediate Panel

No damage was done to the back panel. There was an adhesion of dust about $1\frac{1}{4}$ " in diameter behind the single penetration of the intermediate panel. The decline in panel damage from front to rear is note-worthy. It is apparent in Figure 4-4.407 that the large fragment, or cluster of fragments that did extensive damage at the lower edge of the front panel was diverted downward so it merely nicked the edge of the intermediate panel.

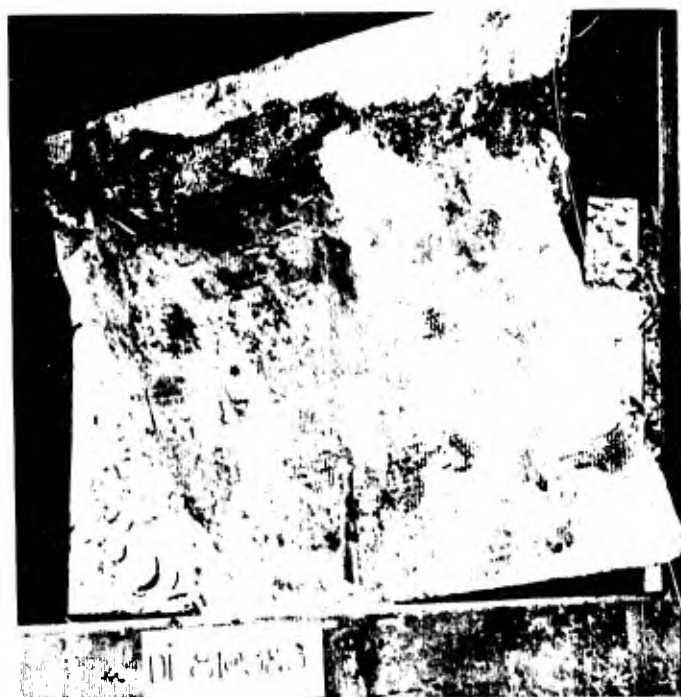
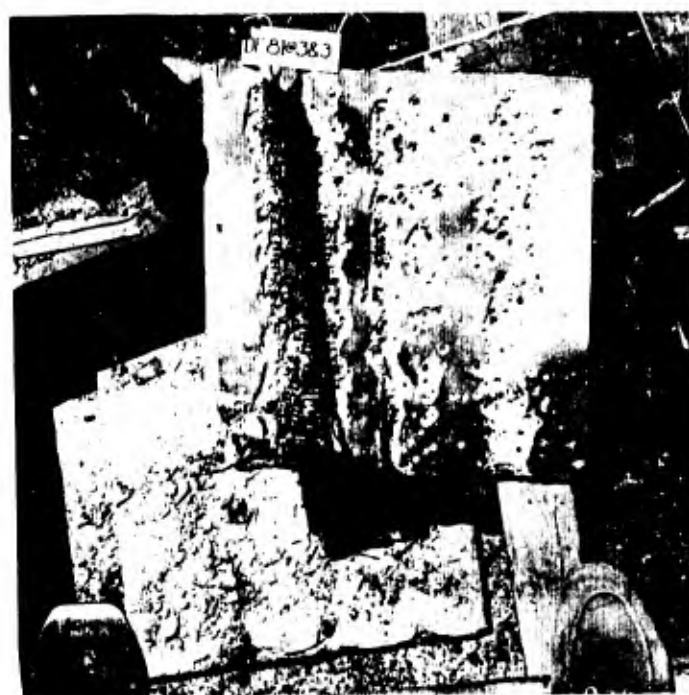
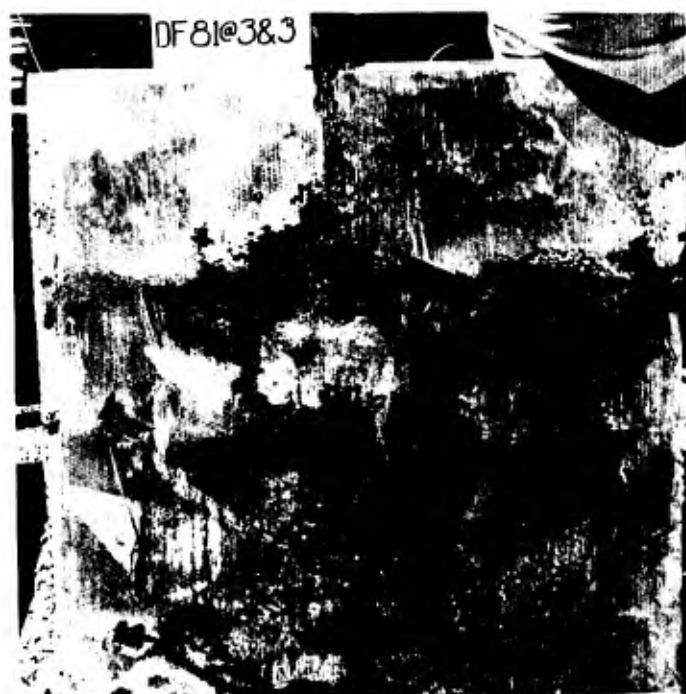
Figure 4-4.504 Upper Surface of Lower Panel in Position After Burst (Debris Removed)

Figure 4-4.505 Lower Surface of Lower Panel

Eight penetrations were identifiable in the lower panel and others may be concealed by the flexural and shear failure. The upper panel, which was free to rise, has a dense pattern of indentations on the lower surface and nine spalled areas with bulged mesh on the upper side. There were three blister-like bulges where the cement adhered to the mesh. The flexural break is near the junction of 27½" and 13-3/4" mesh layers. (These junctions were distributed around the panel.)

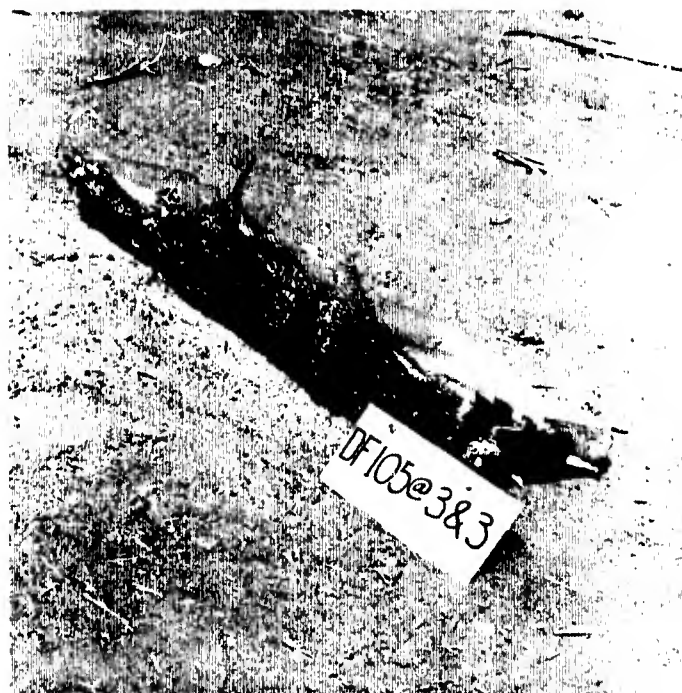
Figure 4-4.603 Piece of Upper Panel Found, Upper Side Down, 20 Feet From the Crib

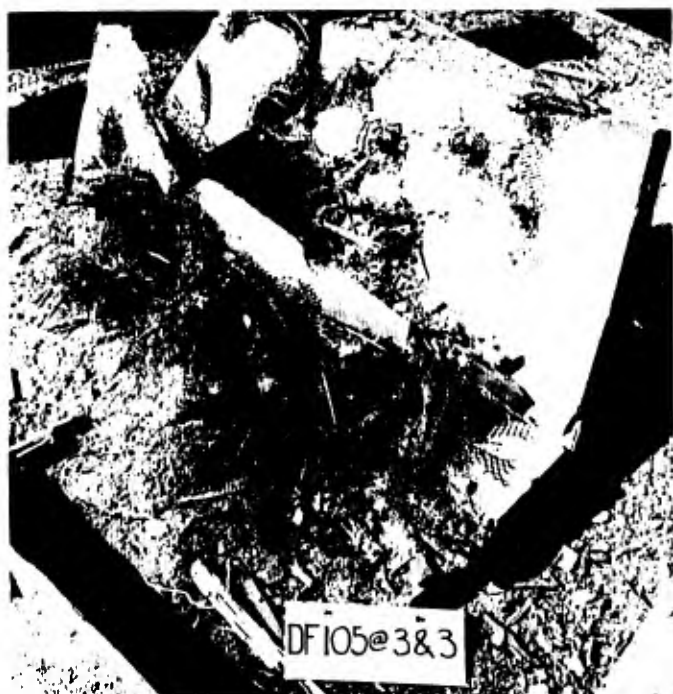
Figure 4-4.604 Another Piece of Upper Panel Found 25 Feet from the Crib in the Opposite Direction

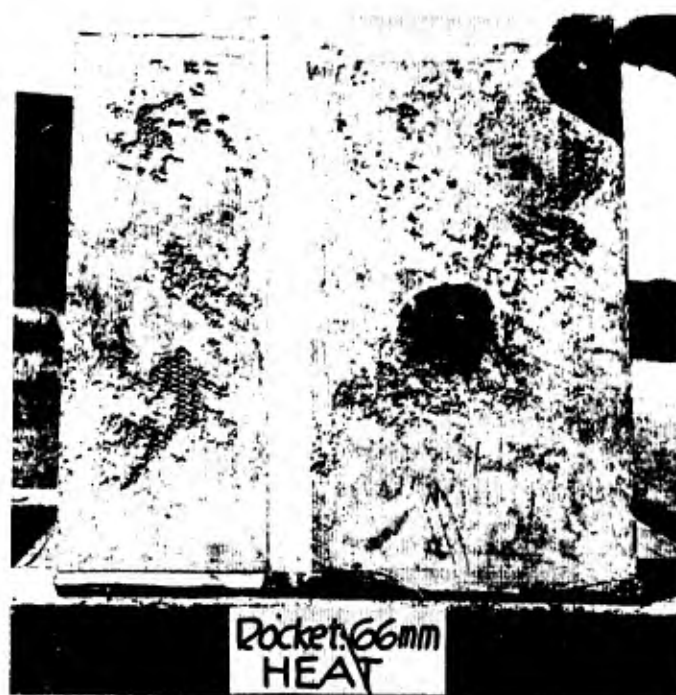
Figure 4-5.206 Bottom Surface of Lower Panel

The penetration of three panels with little evidence of energy loss rejects the panels for protection against shaped charges. Unexpected results of interest are the elongated hole in the top panel and the severing, by flexural failure, of an outside strip about $1\frac{1}{2}$ " in width. Observed unsymmetrical splitting of the shell case indicated sideward blast, which elongated the hole. Pressure over the entire panel exerted negative moment. The reinforcement near the outer edge was reduced by the 24" width of alternate layers (p.2-5).

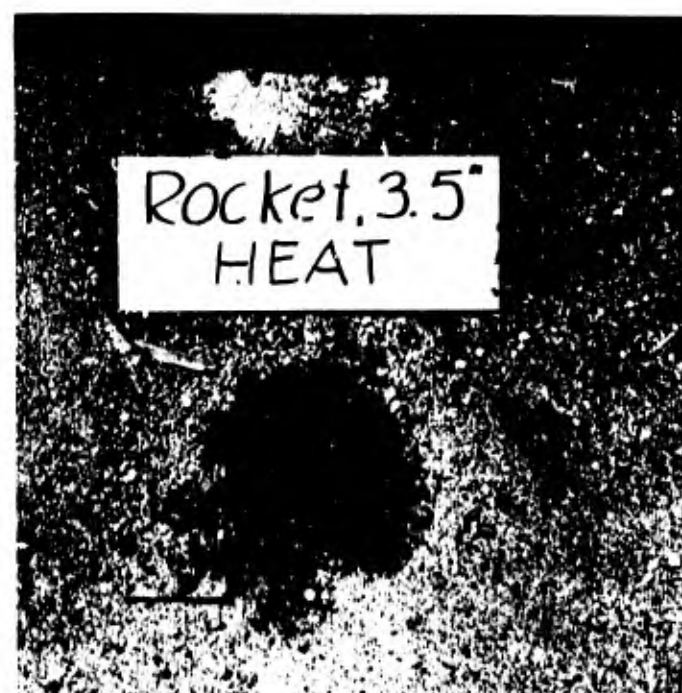
Figure 4-5.307 Hole Drilled 3' into Ground

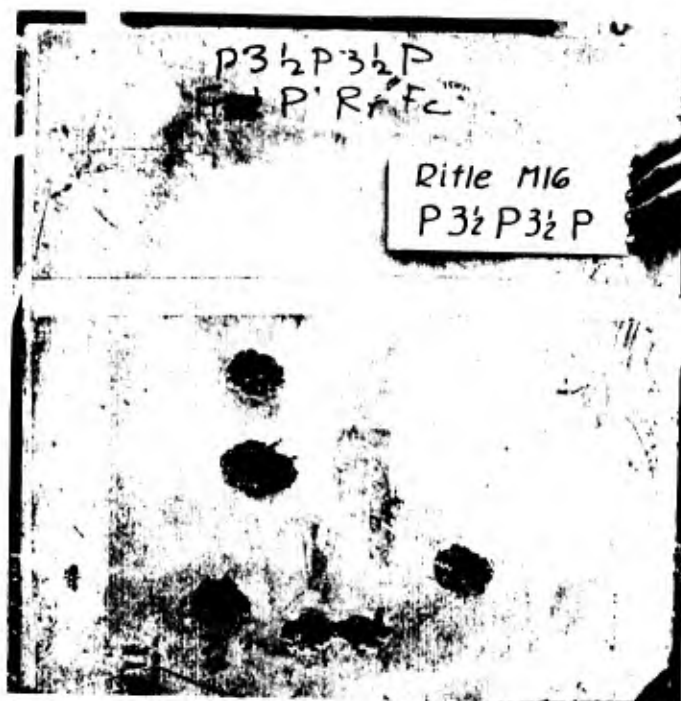
- Figure 4-6.201 Front Face, First Panel, P6½P6½P, is characteristic of all initial bullet entries.
- Figure 4-6.202 Rear Face, First Panel, P3½P3½P, is characteristic of single first panel bullet exits.
- Figure 4-6.203 Rear Face, First Panel, PP6½P, reveals ring of surface shear and prevention, by the interfaced second panel of spalling and mesh rupture in the concentric area.
- Figure 4-6.204 Front Face, Second Panel, P3½P3½P, is characteristic of bullet entries into a single second panel.
- Figure 4-6.205 Front Face, Second Panel, PP6½P, reveals the prevention of spalling by the interfaced first panel.

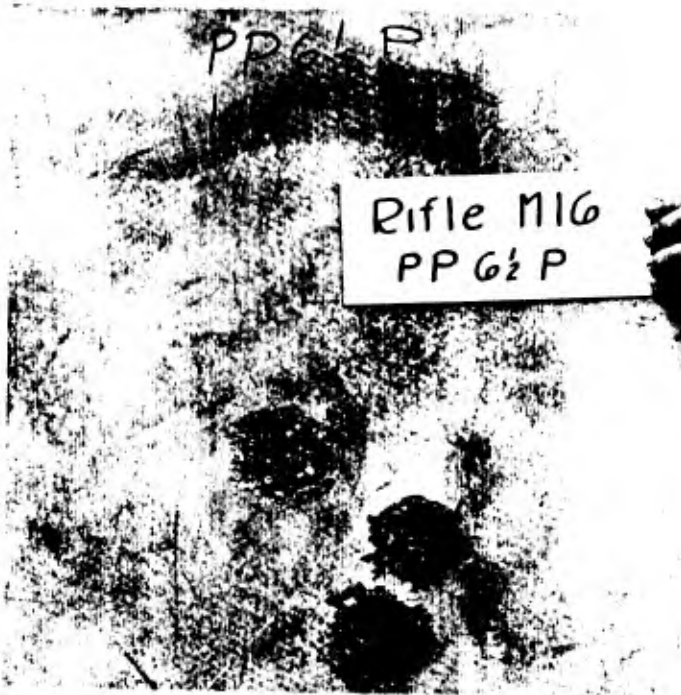
Figure 4-6.206 Back Face, Second Panel, PP6½P, reveals the spalling and, behind the lower hit, the rupture of mesh, which is indicative of shock propagation. The bullets did not penetrate. Apparently, they were fragmented and lodged in the cement. Front face indentations were about ¼".

No second panels were penetrated in the M16 Rifle slow fire experiments. Figures 4-6.206, 4-6.207 and 4-6.209 provide a comparison, in the ascending order of apparent energy absorption of the panel arrangements PP6½P, P3½P3½P and P6½P6½P. The 6½" spacing was indicated to be the most defensive of the first and second panel arrangements mentioned above. Increase in spacing above 3½" appeared to have more effect on the M16 bullet than it had on the .30-06 bullet in the parametric experiments.

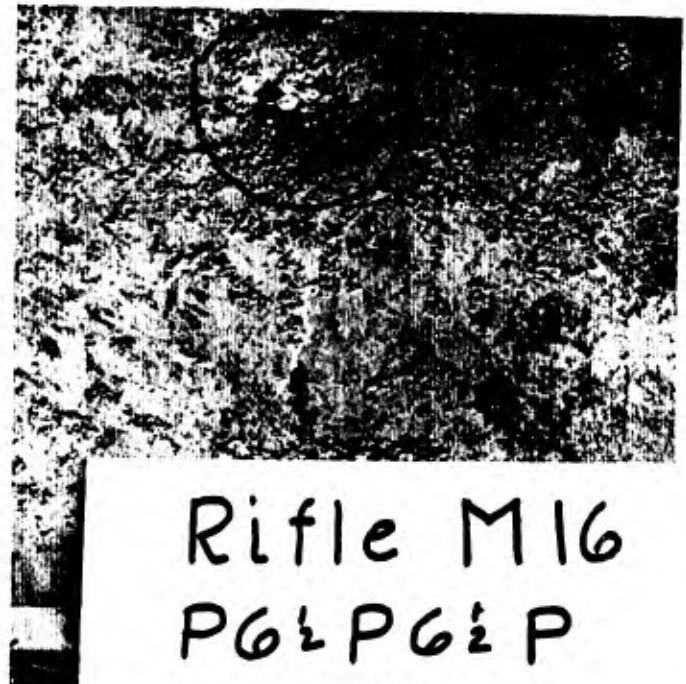
Figure 4-6.209 Rear Face, Second Panel, P6½P6½P, reveals one bulged area with virtually no spall out of the three hits revealed by Fig. 4-6.208.

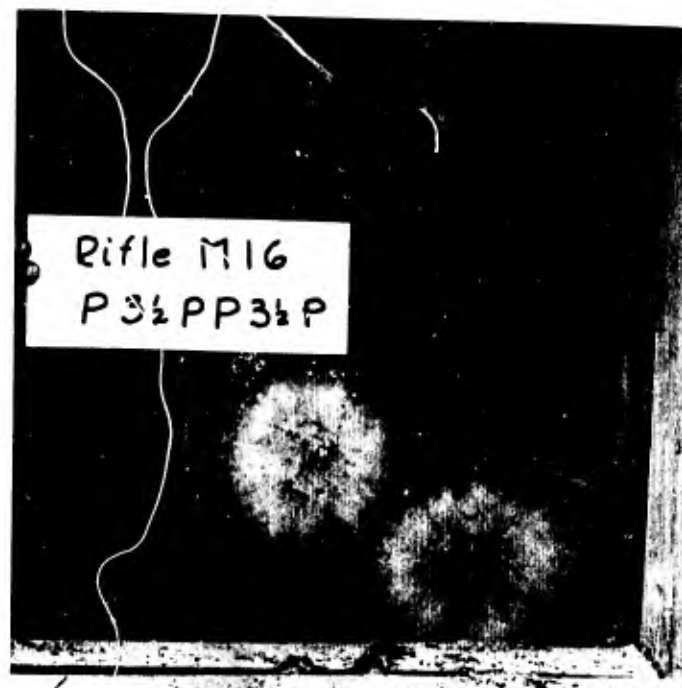
Figure 4-6.211 Front Face, Second Panel, P3½PP3½P, reveals one pronounced indentation and one scarred surface. On the rear face of this panel there was very shallow spalling, 1" to 1½" in diameter, and no bulging. Second panel effectiveness appeared to be improved by the back up of the third panel. The pronounced difference in front face damage between the two hits can be attributed only to randomness in the performance of a bullet after passing through one panel.

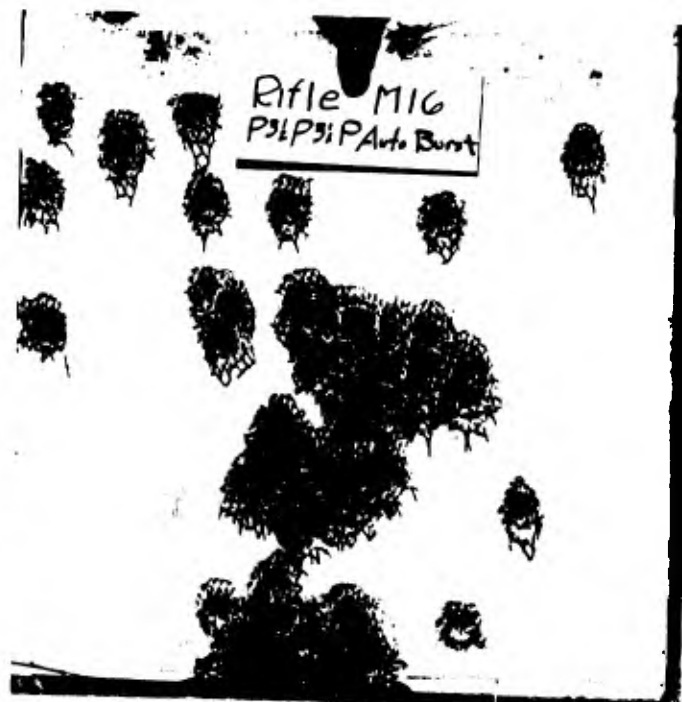
Figure 4-6.213 Rear Face of First Panel, P3½P3½P, reveals the effect of automatic fire. One hundred rounds fired at about 10 yards were all low; approximately half of them were misses and the hits were all at the lower edge, many through the lower 2x4 of the retaining frame. Twenty rounds were then fired into the center of the panel at a range of about 5 yards. The second panel was not penetrated.

Thirty-five additional rounds of automatic fire at 5 yards were then delivered to an area of about 20 square inches about 1/3 of the panel height up from the lower edge (Fig. 4-6.213).

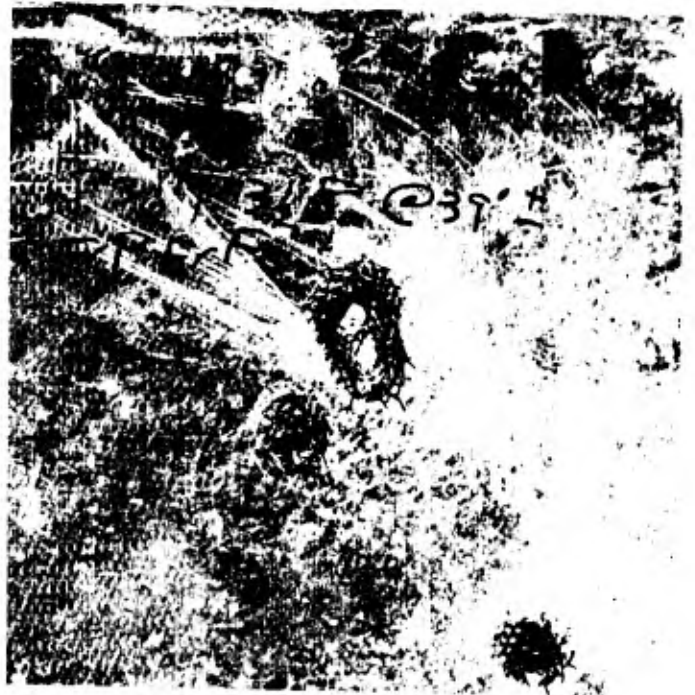
Figure 4-6.216 Front Face, First Panel, P3½P, reveals the enlarged
hole and ruptured metal on the front face at an in-
cident angle of thirty-nine degrees. There was no
damage or marking on the rear panel.

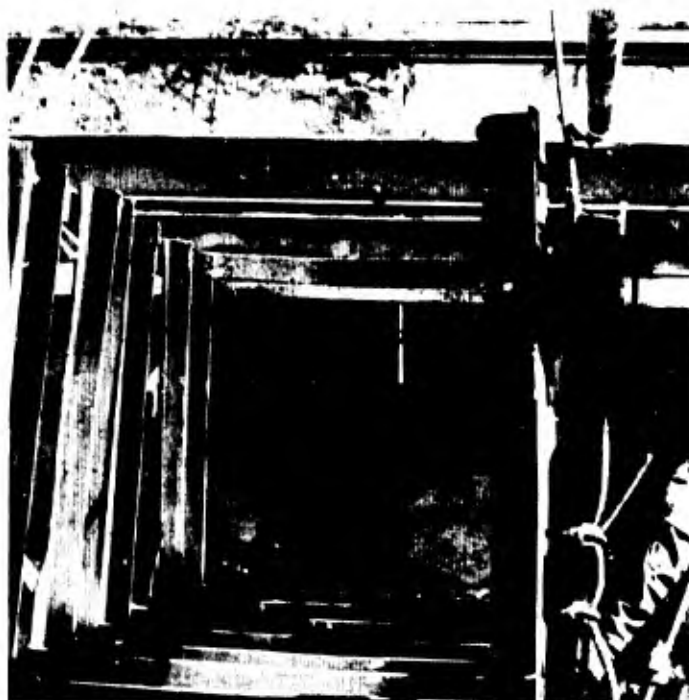
Figure 4-7.403 Separation of Upper Blocks

Upper and lower anchor blocks were separated about 1" and lower blocks appeared to have separated more at the top than at the bottom. (Figures 4-7.403 and 4-7.404)

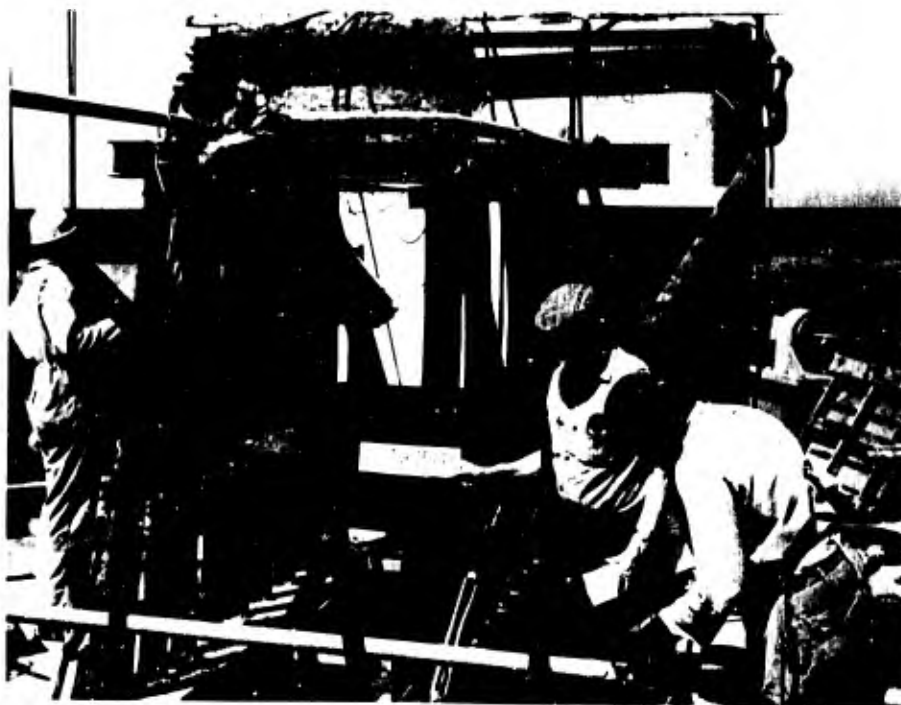
Figure 4-7.602 Supports Being Repaired

Both ends of both pipe struts were broken loose at welds. (Figure 4-7.602)

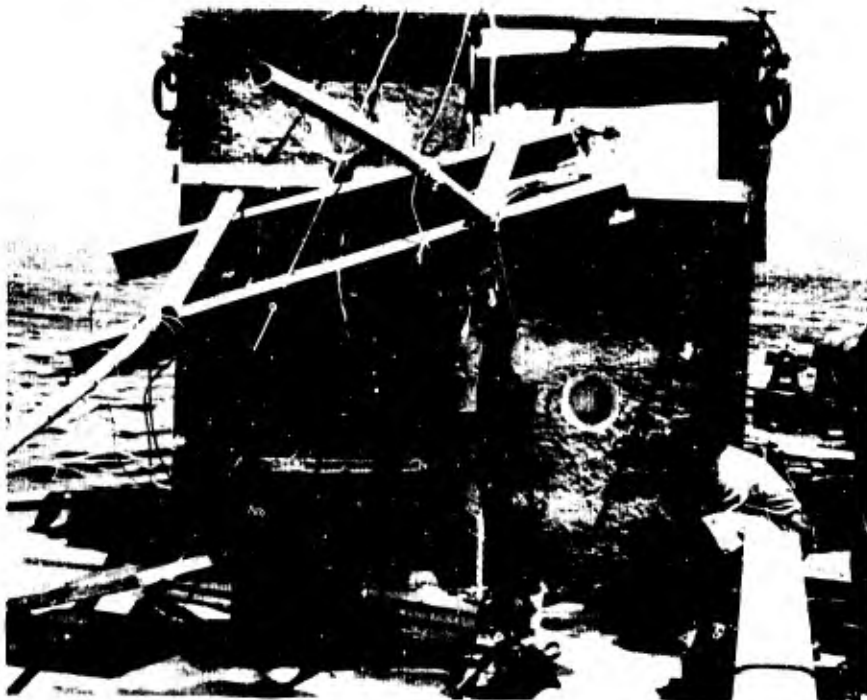
Figure 4-7.1002 Completely Wrecked
Support Frame

The pipe rails and remaining part of the original support frame were completely bent out of shape and almost entirely broken loose from the pier simulator frame. The wreckage was cut entirely free and pipe rails for the tenth and last experiment were welded to the pier simulator frame. (Figure 4-7.1002)

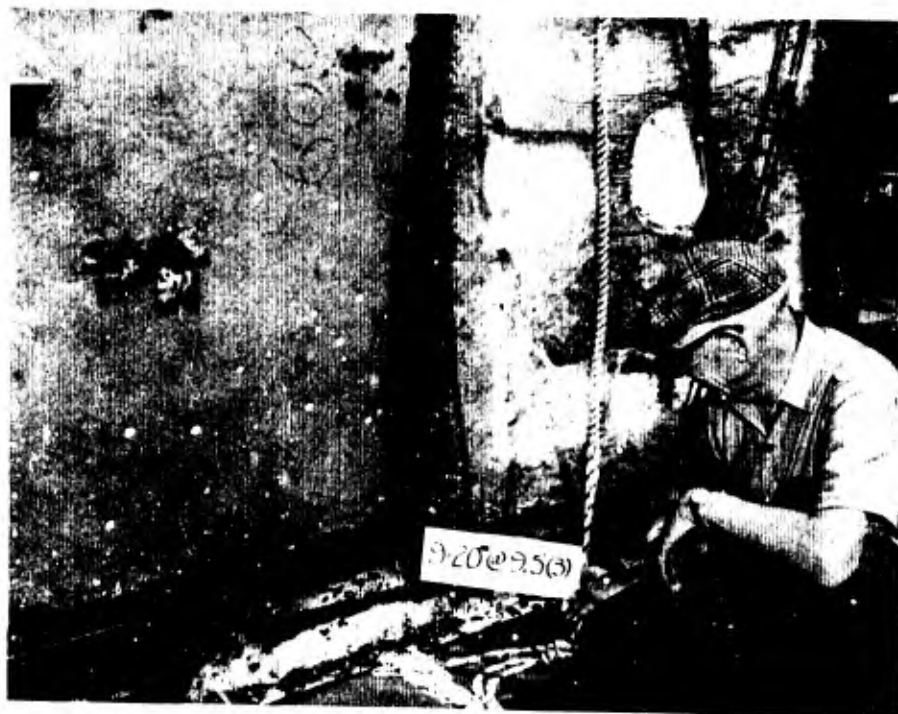
Figure 4-7.1004 Shifting of Blocks in Pier Simulator

The lower right anchor block shifted toward the blast about 4" and the lower left block shifted toward it about 1". (Figure 4-7.1004) The blocks returned to about the position of the seventh experiment.
